SMITHSONIAN INSTITUTION
BUREAU OF AMERICAN ETHNOLOGY
BULLETIN 121

ARCHEOLOGICAL REMAINS IN THE
WHITEWATER DISTRICT
EASTERN ARIZONA

PART I. HOUSE TYPES

By FRANK H. H. ROBERTS, JR.

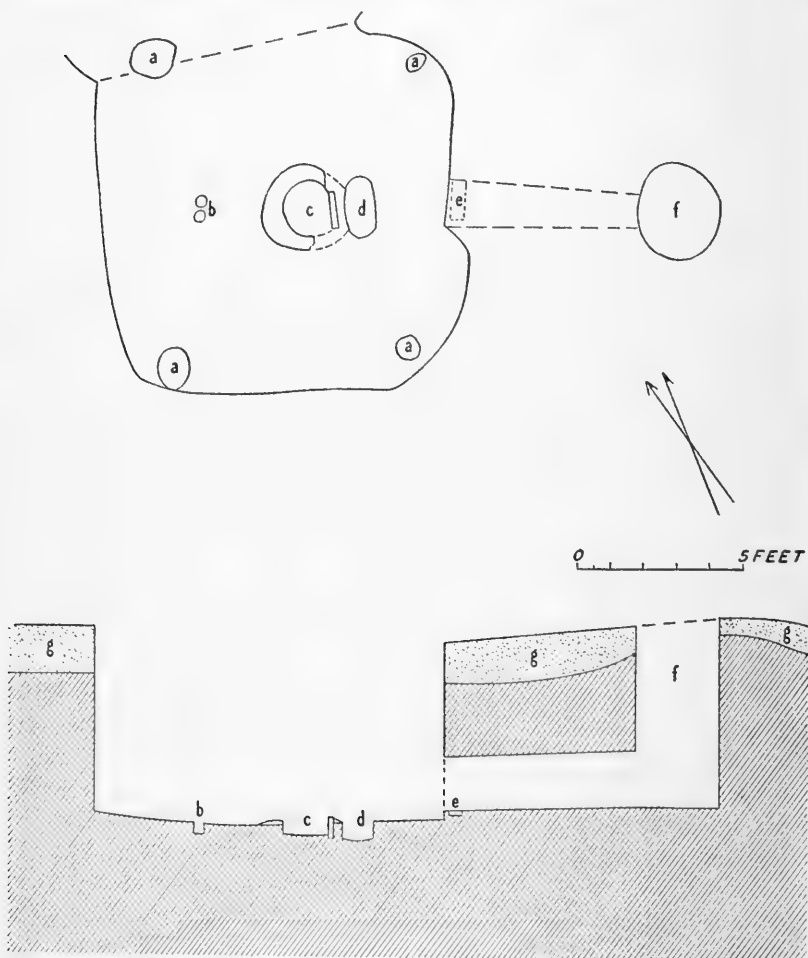
FIGURE 19.—Structure 10. *a*, holes for support posts; *b*, sipapu; *c*, fire pit; *d*, ladder box; *e*, ventilator opening; *f*, ventilator shaft; *g*, accumulation of sand above original surface.

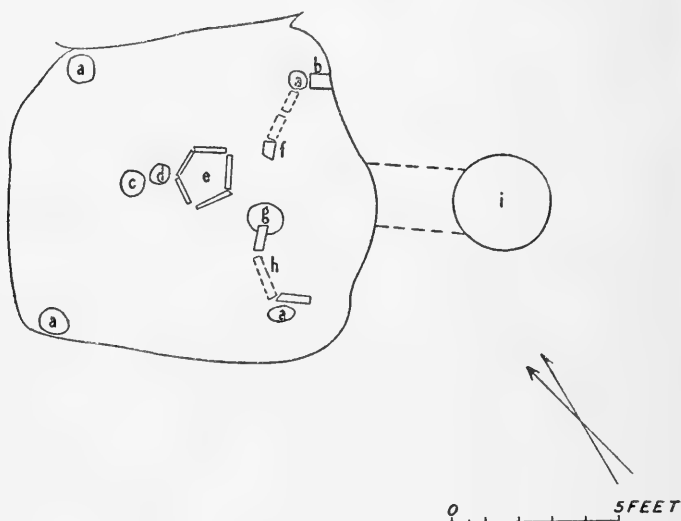
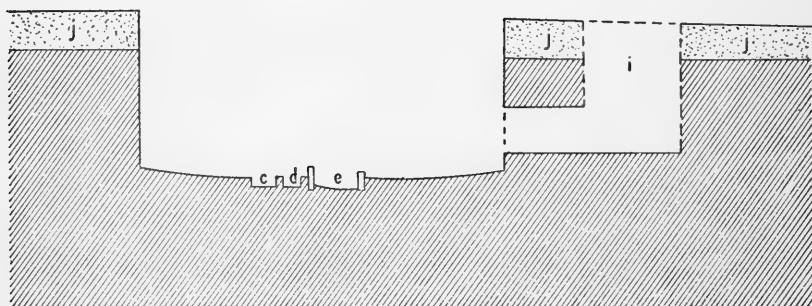
FIGURE 20.—Structure 11. *a*, holes for main support posts; *b*, stone in compartment wall; *c* and *d*, holes in floor in position of sipapu; *e*, fire pit; *f*, stone in compartment wall; *g*, storage basin; *h*, stone mold; *i*, ventilator shaft; *j*, accumulation of sand above original surface.

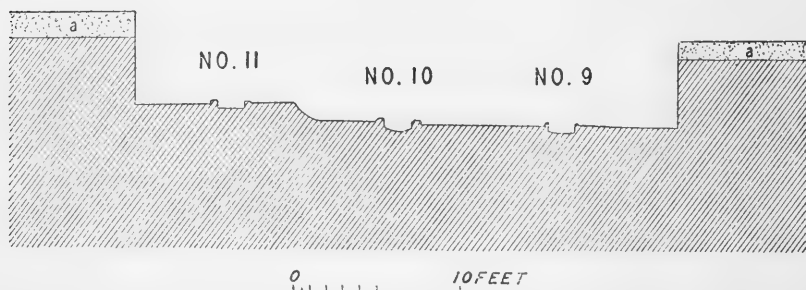
FIGURE 21.—Section through structures 9, 10, and 11. *a*, accumulation of drifts and above old surface.

The floor space for No. 11 was distinct from that of Nos. 9 and 10 inasmuch as it was at a higher level (fig. 21). In this respect it corresponded to the relationship between structures 6 and 7 where a difference in levels was also noted.

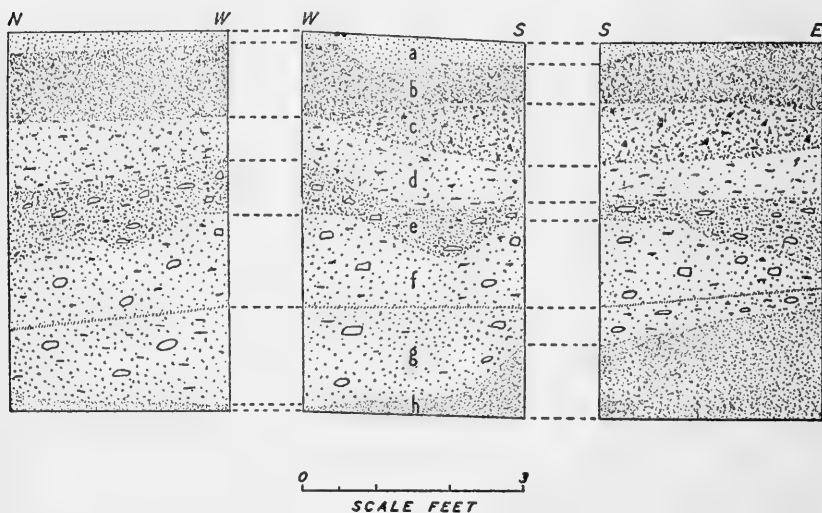
FIGURE 22.—Test pillar from fill in structure 10. N, W, S, and E, indicate north, west, south, and east corners.

The pillar left in the center of structure No. 10 to facilitate a study of the fill in the pits had a height of 5 feet 2 inches (1.574 m). There were 8 distinct strata in the pillar and the material contained in each layer was quite dissimilar in character to that in the others (pl. 11, *a*). The first stratum at the top consisted of rather coarse, clean yellow sand that apparently had been carried into the pit by wind action. The layer was somewhat uneven, as the diagram (fig. 22, *a*) shows. A shallow ditch ran through the top of the fill along the line that approximately cut the group of three structures through the longitudinal center. This may be attributed to the fact that the pits were located on the side of the ridge where there was a double slope, one extending from the west walls of the chambers toward the ventilator sides of the structure and the other from No. 11 toward No. 9. The original ground level at the north side of No. 9 was somewhat lower than that at the south side of No. 11 (fig. 21). In addition, there originally had been a second ridge just beyond the series of ventilator shafts. At the time when the houses were occupied there was a small gully between the edges of the ventilator shafts and the slope of the second ridge. It no doubt carried away all surface drainage from around the structures. After they were abandoned, fell into decay, and the pits had become filled with accumulated debris, the wind shifted sand across the site and piled it up against the ridge to the east. As a result its western slope was extended until it covered the old ventilator shafts and shifted the drainage channel, for the small area involved, several feet. It then passed over the subterranean portion of the houses, cutting the gutter indicated in layer *a* in the central face in the group of three shown in the diagram (fig. 22). That this took place subsequent to the abandonment of the site was indicated by the fact that there were no potsherds, bone fragments, stone chips, or charcoal in the layer. Layer *a* varied in thickness from 6 inches (15.24 cm) at the center of the ditch to 1 inch (2.54 cm) at the corner of the pillar. The thinnest portion was at the east side where there was an upward slope toward the east ridge beyond the ends of the ventilators.

The second layer in the pillar (fig. 22, *b*) was composed of discolored sand mixed with a considerable amount of humus. This layer

also appeared to be subsequent to the occupation of the site. Presumably there had been considerable vegetation on the surface of *b* for a fairly long period of time prior to the deposition of the top stratum of clean sand. This vegetation with the attendant decay of the plant matter was what gave the color to the sand and was responsible for the humus content. As will be seen from the drawing (fig. 22, *b*), this layer was somewhat irregular in outline. It was thickest on the west side and as in the case of the upper layer sloped upward toward the east. The stratum ranged in thickness from $6\frac{1}{2}$ inches (16.51 cm) to 1-foot (30.48 cm).

Stratum *c* was of interest because it was not continuous throughout the course of the three pits, in an east-and-west direction. It occurred as a lens extending from north to south along the east

side of the fill. The material apparently washed into the pits. The layer immediately below had been deposited with a pronounced downward slope toward the eastern edge, and *c* evened up the surface of the fill. It extended across from approximately the high point on *d*, the stratum below, to the east edge of the excavation. Stratum *c* contained some fragments of charcoal, some ash-bearing sand, and occasional nodules of adobe. In its general appearance it was somewhat darker than the stratum immediately above. From the point where it coincided with stratum *d*, layer *c* expanded to a depth of 10 inches (25.4 cm) at the south side of the pillar and narrowed to 6 inches (15.24 cm) at the east side. At the west side of the pillar strata *b* and *d* touched.

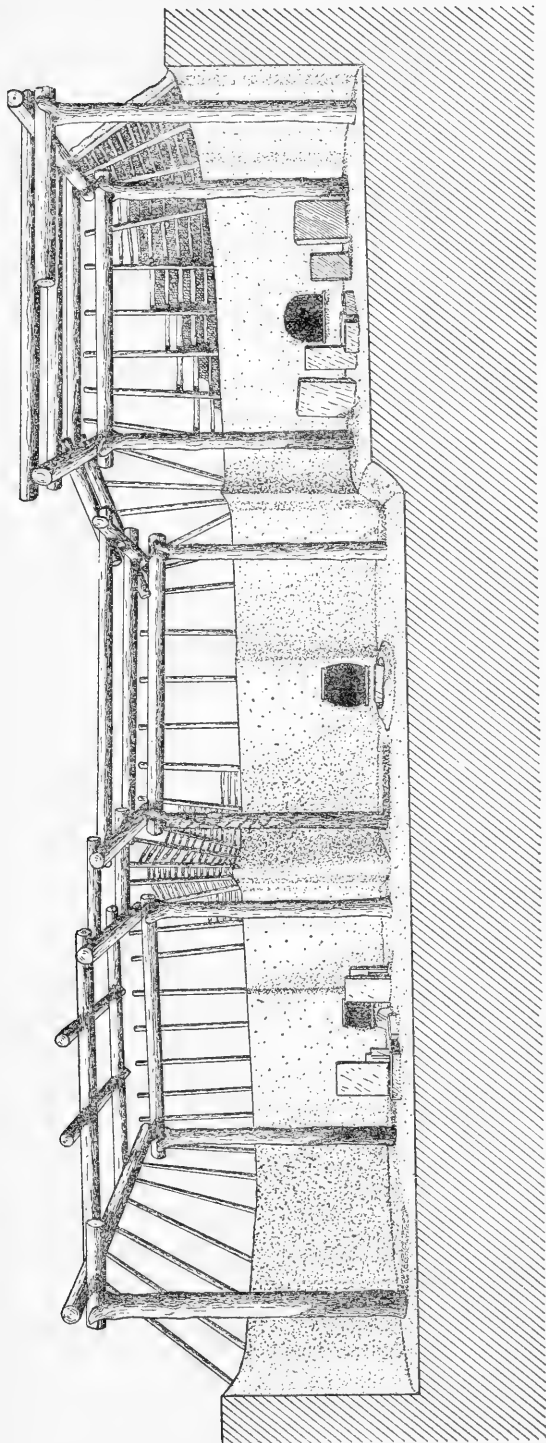
FIGURE 23.—Postulated reconstruction of timber arrangement in superstructure erected over pits 9, 10, and 11. Some of main support posts omitted at front of drawing to show construction more clearly.

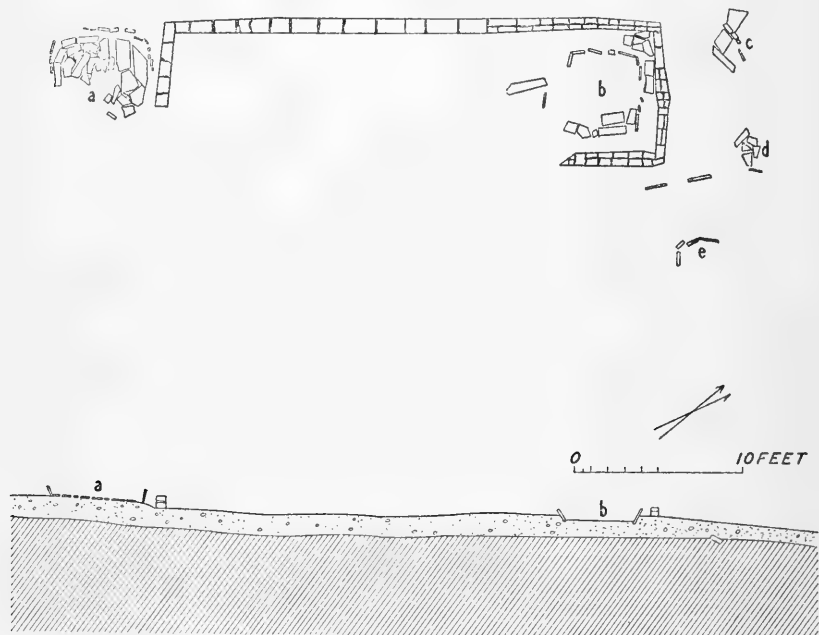
FIGURE 24.—Surface remains B in first group. Granary pits at *a*, *b*, *c*, and *d*; exterior fire pit at *e*.

At the south end of the masonry walls were the remains of a storage cist (fig. 24, *a*). This cist was roughly rectangular in form, judging by what remained of it, and although the sides were fairly straight the corners were rounded. This place probably was a granary in which corn was stored. Just what type of superstructure was erected over it is not known. Possibly a framework of poles and brush was placed over it and the exterior surface was covered with plaster. The main timbers probably sloped from the ground level

Within the inclosure formed by the rectangular wall were the remains of a similar cist (fig. 24, *b*). If the surface structure had been a house it is hard to explain why a granary had been built within it. On the other hand, it is possible that the feature in the north end of the structure does not represent such a granary but merely a slab-lined depression in the floor which served either for storage purposes or as a mealing bin.

Outside the inclosure at the north end was what remained of two additional cists (fig. 24, *c*, *d*). In addition, there was an exterior fire pit 5 feet (1.524 m) from the northeast corner of the masonry walls (fig. 24, *e*).

In general it may be said that the surface remains at this portion of the site corresponded in age to the group designated surface house A. They gave evidence of being later than the nearby pit structures 6, 7, 8, 9, 10, and 11. This was demonstrated by the fact that the foundations of the stone walls and the granaries were at a higher level than the surface of occupation at the time when the pit structures were inhabited. This is shown by the section through the building (fig. 24).

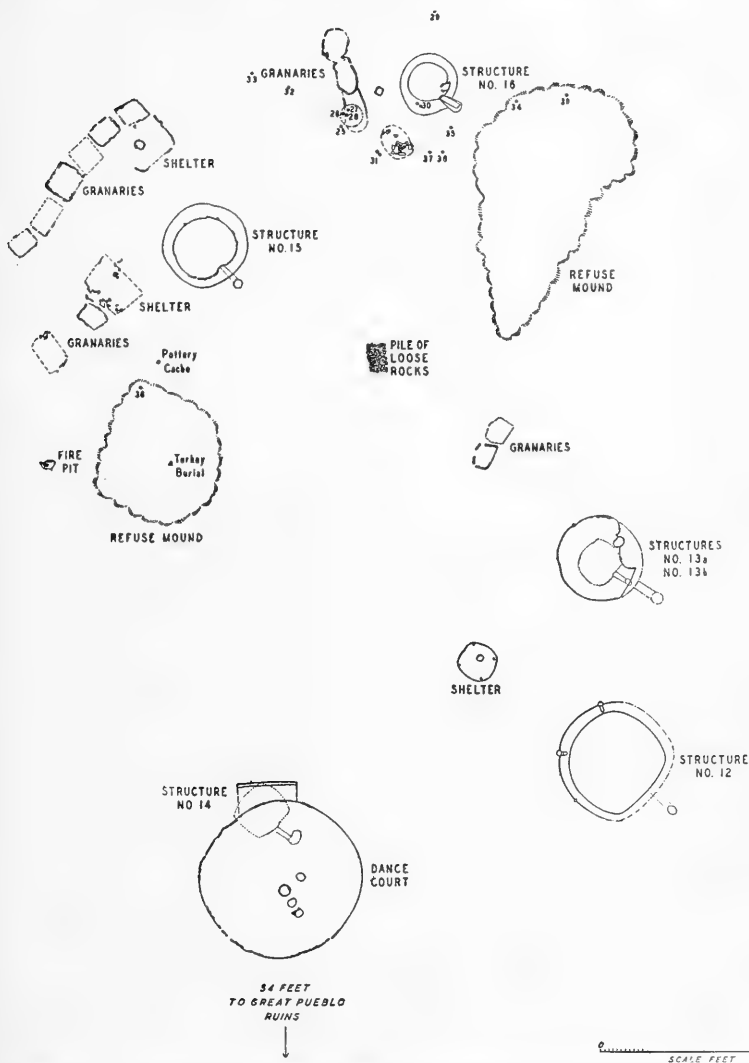
FIGURE 25.—Group 2 pit and surface remains. Numbered dots indicate location of burials.

Structure 12 was the first of the remains uncovered in the second group. It is located along the edge of the ridge north of the Great Pueblo ruins and at a considerable distance from the group discussed in preceding pages (fig. 25). A large portion of the east wall had been carried away by erosion, but the damage was not sufficient to destroy all the evidence essential to a reconstruction of the structure. The pit was much deeper than in many of the other examples and for that reason the major outline of the subterranean portion of the structure was still intact. Structure 12 was the largest of the entire group and differed from the others in that it had a bench encircling the upper borders of the pit. The pit was definitely D-shaped and more regular in outline than the majority of the excavations (fig. 26). The back of the bench was not as uniform as the main wall of the chamber but nevertheless conformed rather closely to its perimeter.

Structure No. 14 was located on top of the ridge some distance west of 12 and southwest from 13a and 13b (fig. 25). The significant factor about the remains of No. 14 was that they were partially covered by a rather unusual feature in the form of a dance court. The latter had been placed there after structure 14

The pile of loose rocks located 27 feet (8.230 m) northwest from these granary pits (fig. 25) apparently consisted of material gathered for use in construction work. The stones were arranged in an orderly fashion, although simply piled there, and were not the remains of a fallen house. Perhaps they had been carried there from the sandstone ledges along the edge of the mesa and were waiting to be shaped and dressed for inclusion in a structure that was never built. There was nothing to show what stage in the history of the site was represented by this feature, although their location and the nature of the surrounding earth suggest that it was subsequent to the existence of the not far distant structure No. 15.

The remains of structure 15 and the nearby granaries and shelters present an interesting example of a prototype for a unit or single-clan form of dwelling (fig. 25). The group as a whole is especially significant from the standpoint of the evolution of a characteristic late Developmental Pueblo type of house. Structure 15 was a typical pit dwelling of the form more commonly found in the regions north and east from the Allantown district, particularly the Chaco Canyon area. The pit was roughly circular in form and had an encircling bench (fig. 36). Both bench and inner pit were dug into the earth, although the bench was quite shallow. The back wall was just high enough to serve as a footing for the sloping side timbers of the superstructure. The top of the bench was covered with adobe plaster, but the back wall was not so treated and its face was merely the native earth. The wall of the main pit, however, had a facing

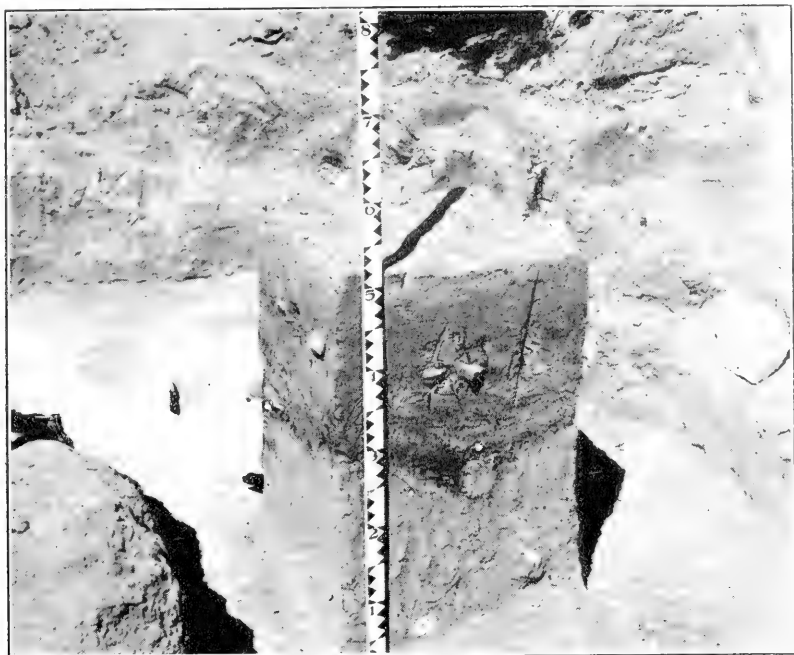
a. Pillar left from fill in pit for structure 10.

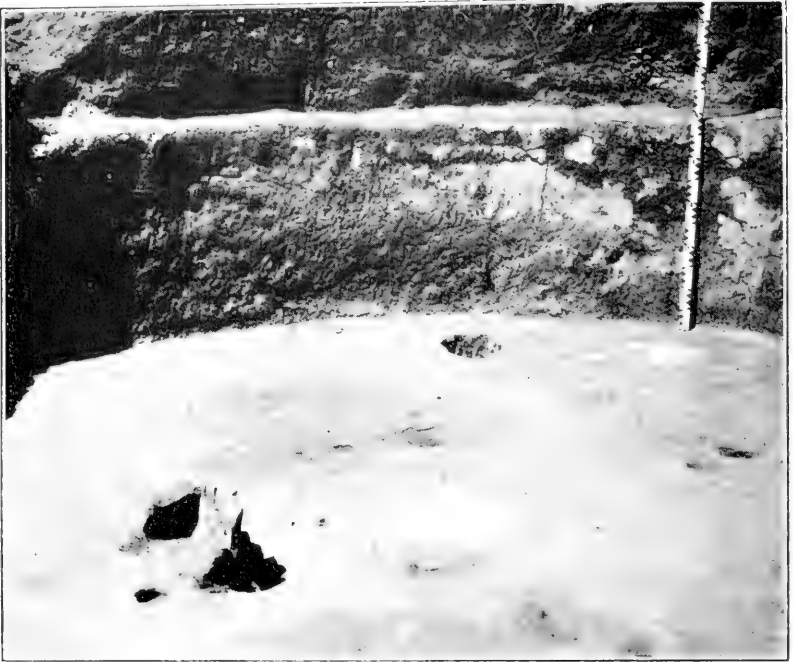
a. Floor in structure 12, showing ladder holes, deflector, ash and fire pits.

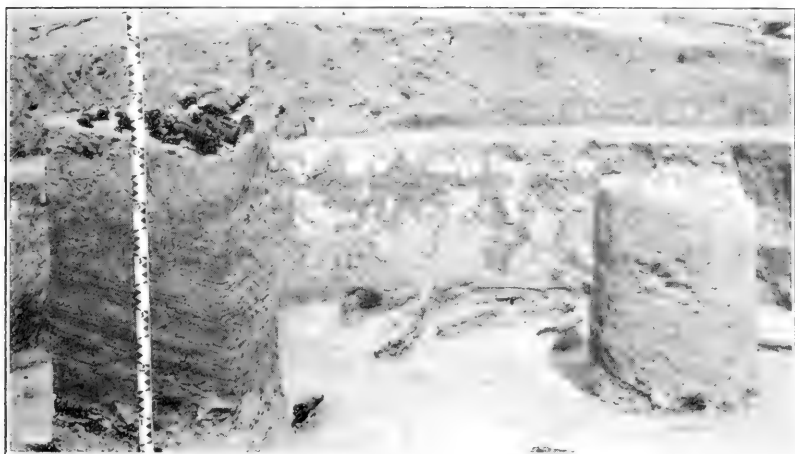
a. Pillar from fill, fire pit in fill, and logs on floor of structure 12.

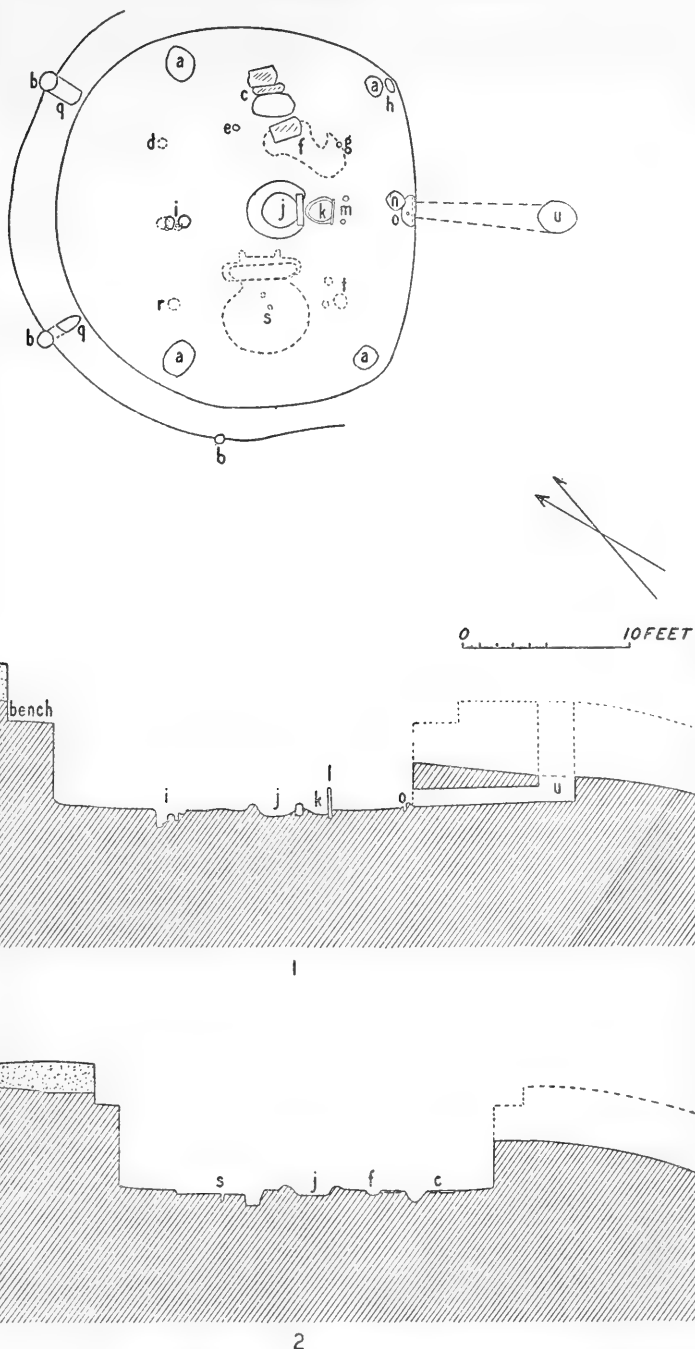
FIGURE 26.—Structure 12. *a*, holes for main support posts; *b*, secondary supports at back of bench; *c*, paving on floor; *d*, plastered-over hole in floor; *e*, storage hole; *f*, plastered-over basin; *g*, storage hole in floor; *h*, storage basin; *i*, sipapu holes; *j*, fire pit; *k*, ash pit; *l*, deflector; *m*, ends of ladder poles; *n*, cover stone for ventilator; *o*, shelf for cover stone and hole for small post to hold stone; *q*, plaster ridges on bench; *r*, plastered over hole; *s*, plastered over basin suggestive of subfloor kiva vault; *t*, plastered-over holes; *u*, ventilator shaft; *v*, sand accumulation.

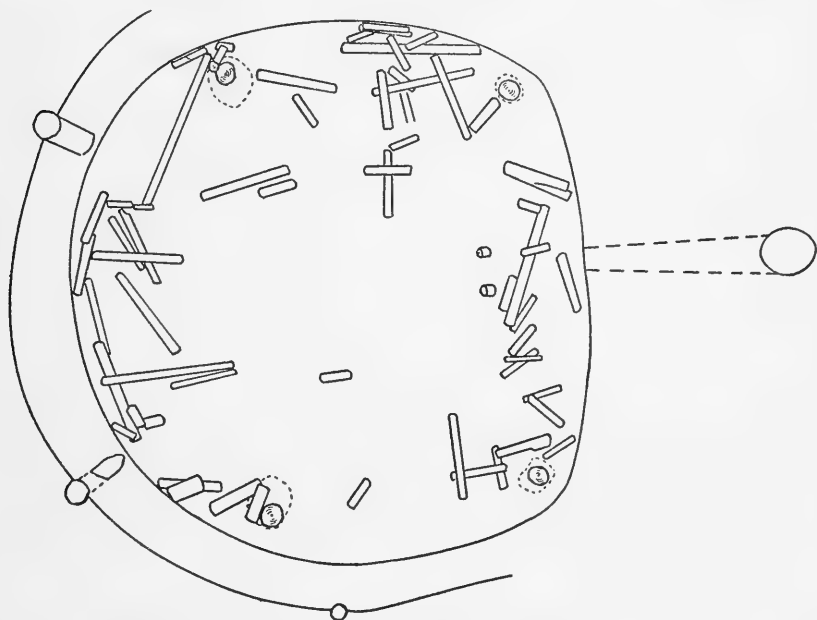
FIGURE 27.—Positions of burned timbers on floor of structure 12.

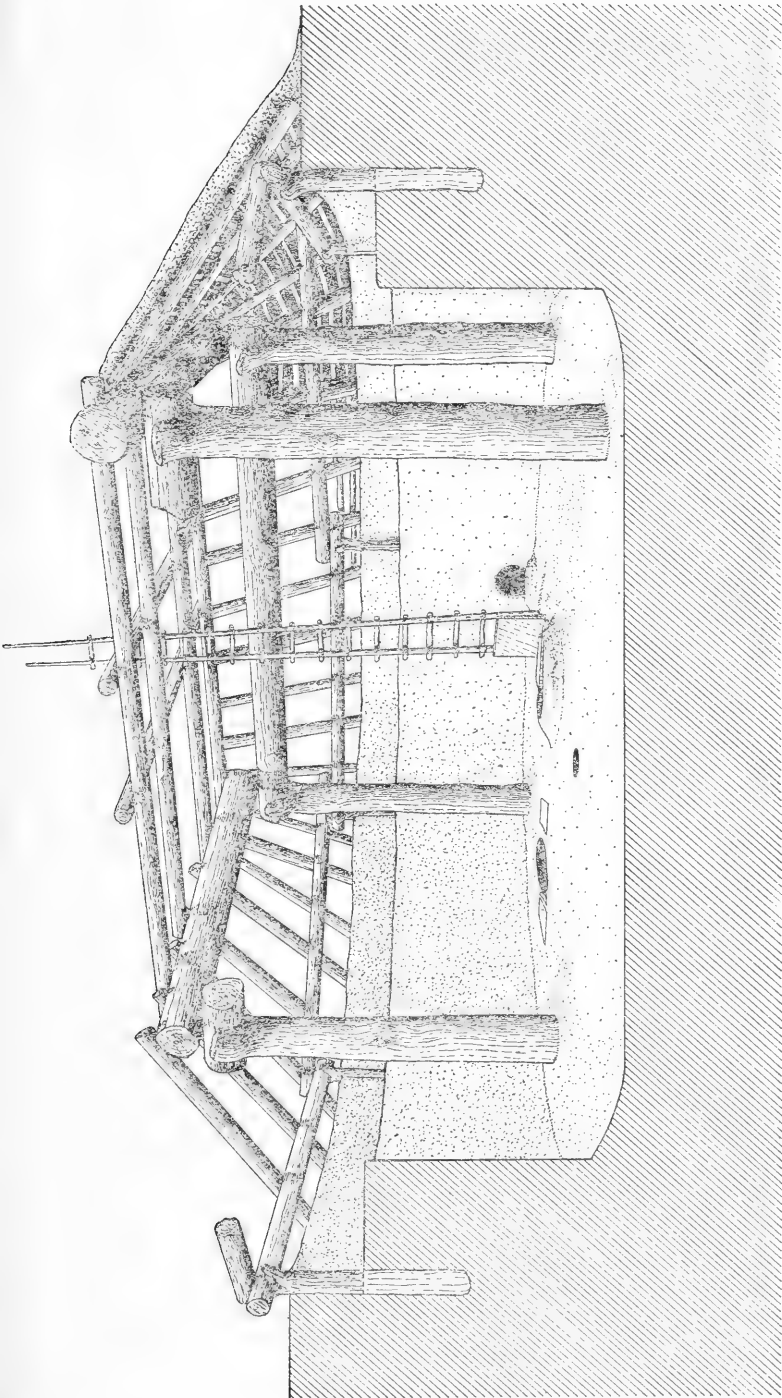
FIGURE 28.—Postulated reconstruction of superstructure erected over structure 12. Some of front timbers omitted from drawing so as not to complicate the diagram.

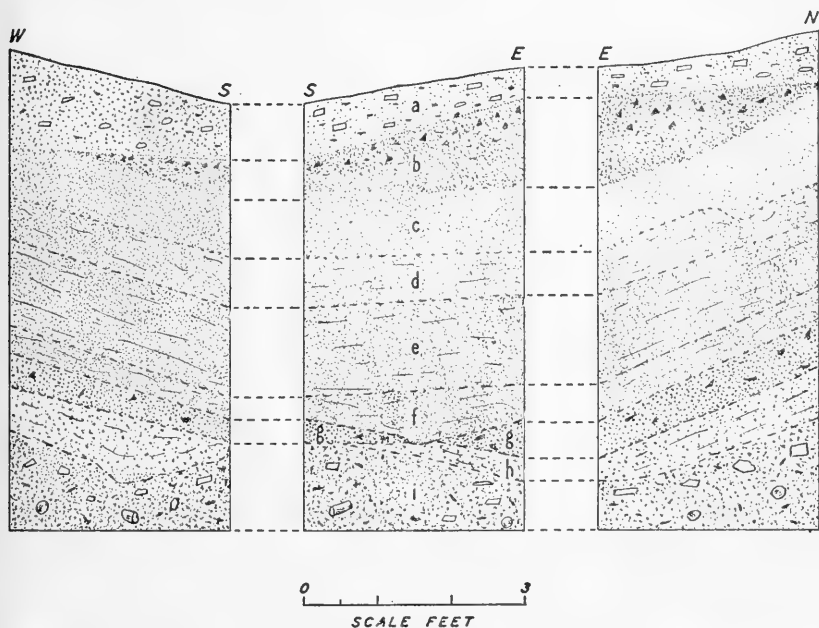
FIGURE 29.—Pillar left from fill in structure 12. E, W, N, and S indicate east, west, north, and south corners.

The fill in the subterranean portion of this structure was somewhat different in character from that found in most of the pits. The first layer in the pillar (fig. 29, *a*) consisted of wind-blown sand. It contained some fragments of tabular sandstone, and potsherds were comparatively numerous. The stratum was uneven, probably due to the house being on the slope of the hillside. At the east corner of the pillar it measured 5 inches (15.27 cm), at the north corner 8½ inches (21.59 cm), at the south 9 inches (22.86 cm), and at the west was 1 foot 4½ inches (41.91 cm) thick.

Layer *c* was practically the same in content as *b*, except for the fact that it contained less charcoal. The main line of demarcation between the two was a distinct streak of water-deposited sand and clay. This line was on an old surface of occupation at about the level of the top of the bench. On this same surface, in another part of the room, was a fire pit that had been placed in the fill at a considerable height above the old floor (pl. 13, *a*). The material in stratum *c* was charcoal, adobe nodules, sand, and some clay. There were a few sandstone spalls and some bone fragments. Potsherds were present, but were not as numerous as in the layer above. Measurements for this stratum were: north corner 1 foot 4 inches (40.64 cm), east corner 10½ inches (26.67 cm), south corner 9½ inches (24.13 cm), and west corner 8½ inches (21.59 cm). Strata *a* and *c* came together at the west corner because of the lens nature of stratum *b*.

The next two strata, *d* and *e*, were clearly defined by streaks of charcoal. The material in the layers was the same as that for stratum *c*. The main differences were that there was a slight increase in the amount of stone fragments present in *d*, with a sharp drop in *e*. The number of potsherds present in *d* was the same as that for *c*, but a marked decline was noted in *e*. At the top of *d*, in the face of the pillar between the east and north corners (fig. 29), was a small pocket filled with water-deposited sand. This apparently was the remnant of a shallow puddle where water had collected in a depression when the top of *d* was the surface of the ground at that point. Stratum *d* measured: 6 inches (15.24 cm) at the north corner,

7 inches (17.78 cm) at the east corner, 8 inches (20.32 cm) at the south corner, and 7 inches (17.78 cm) at the west corner. Stratum *e* had thicknesses of 10½ inches (26.67 cm) at the north corner, 1 foot 2½ inches (36.83 cm) at the east corner, 1 foot 2½ inches (36.83 cm) at the south corner, and 1 foot 2 inches (35.56 cm) at the west corner.

Stratum *f* was characterized by considerable quantities of burned sand, charcoal, lumps of clay, and a good showing of bone fragments. There was no stone and a total absence of potsherds. The layer was rather thin, except near the center of the east-south and west-north faces where a channel in the top of *g* increased the thickness. The stratum measured 5¼ inches (13.33 cm) at the north

Stratum *g* was separated from *f* by a layer of charcoal. The stratum contained numerous lumps of clay, adobe nodules, some burned sand, and wood ashes. The amount of bone was the same as that for the level above, but in addition there were fragments of stone and a few potsherds. Stratum *g* measured 8 inches (20.32 cm) at the north corner, 7 inches (17.78 cm) at the east corner, 4 inches (10.16 cm) at the south corner, and $5\frac{1}{2}$ inches (13.97 cm) at the west. The small channel noted in the discussion of *f* completely cut through *g* and at that point strata *f* and *h* touched. The channel was 5 inches (12.7 cm) wide.

Stratum *h* was separated from *g* by a definite line of charcoal and ash. The layer had a larger content of sand than was the case in *g* and in addition some ashes, bits of charcoal, lumps of adobe, and balls of clay. There was a total absence of bone, stone, and potsherds. The layer measured: $8\frac{1}{2}$ inches (21.59 cm) at the north corner, $3\frac{3}{4}$ inches (9.53 cm) at the east corner, was missing at the south corner, and $7\frac{1}{2}$ inches (19.05 cm) at the west corner. About midway of the west-south face an old depression in the top of the layer below increased the thickness of *h* to 11 inches (27.94 cm). This pocket was 8 inches (20.32 cm) across and its bottom was filled with water-deposited sand.

Stratum *i* rested on the floor of the structure and consisted largely of burned plaster, charred beams, chunks of adobe, sand, and ashes. There were numerous fragments of sandstone, chips of chert and chalcedony, bits of bone, and a fairly good showing of potsherds. This layer was also irregular in thickness due to an uneven top surface with humps and pockets attributable in the main to the timbers and charred bits of roofing in the debris and to features on the floor. The layer measured: 1 foot 6 inches (45.72 cm) at the north corner, 8 inches (20.32 cm) at the east corner, 1 foot 2 inches (35.56 cm) at the south corner, and 1 foot 4 inches (40.64 cm) at the west corner.

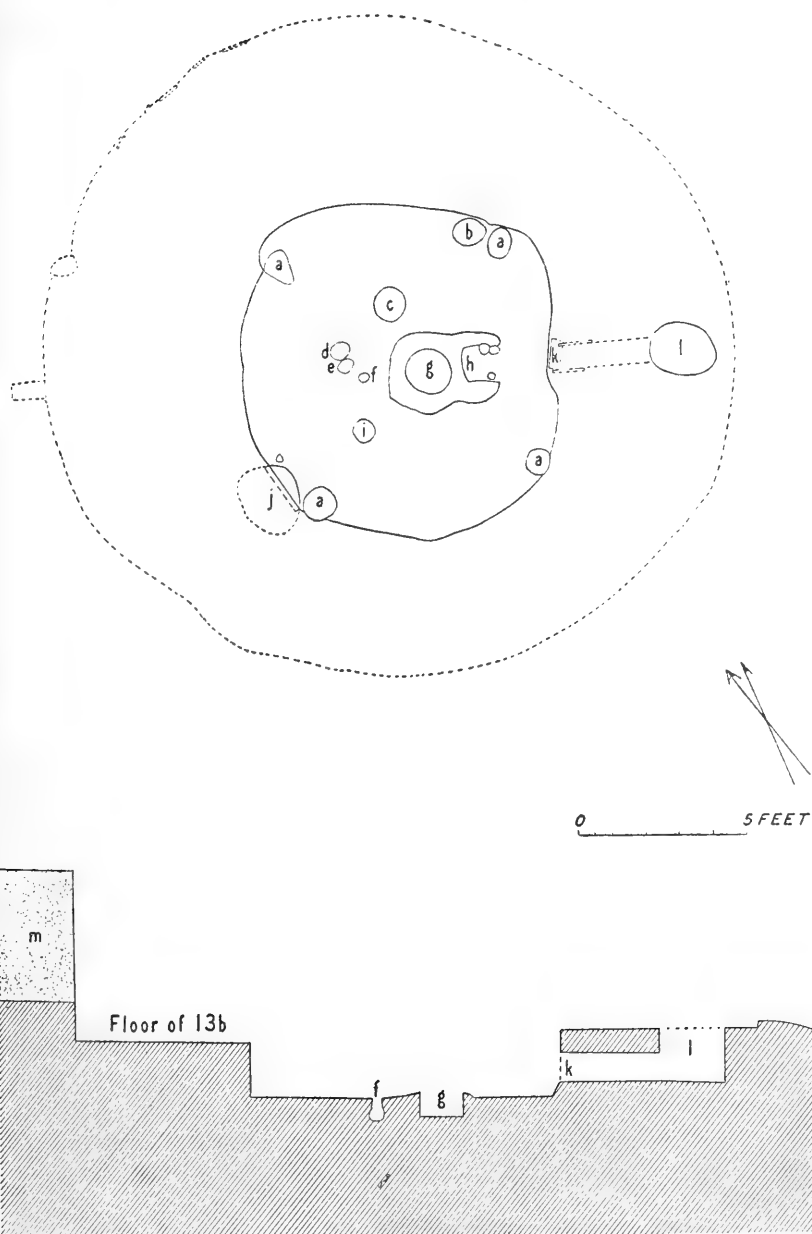
FIGURE 30.—Structure 13a. *a*, holes for superstructure support posts; *b*, *c*, *d*, and *e*, storage holes; *f*, sipapu; *g*, fire pit; *h*, ladder box; *i*, storage basin; *j*, storage pocket in wall; *k*, ventilator opening in chamber; *l*, ventilator shaft; *m*, accumulated sand. Dotted lines indicate position of 13b.

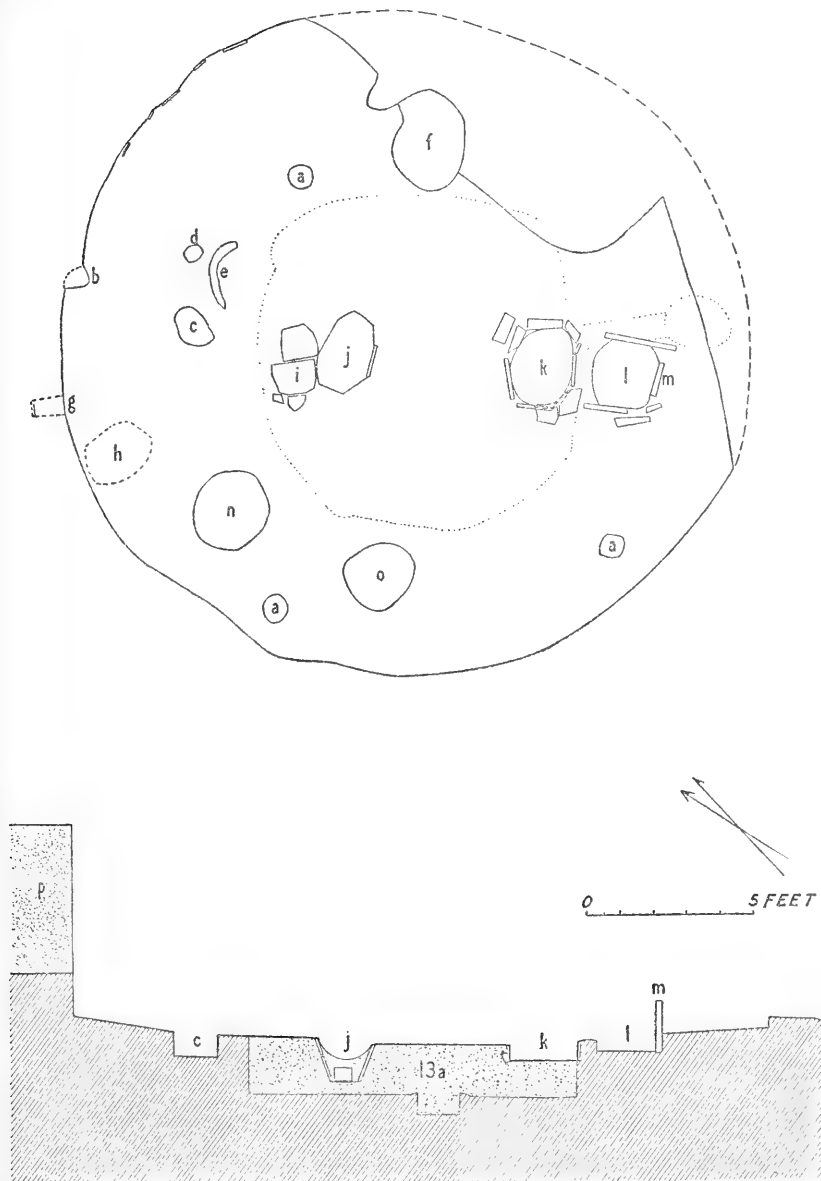
FIGURE 31.—Structure 13b. *a*, holes for main support posts; *b*, beam placement; *c* and *d*, storage holes; *e*, groove in floor; *f*, storage basin; *g*, wall pocket or Katsina niche; *h*, basin covered by floor plaster; *i*, stones embedded in floor; *j*, basin in floor; *k*, fire pit; *l*, ladder box; *m*, deflector stone; *n* and *o*, storage basins; *p*, drift sand. Dotted lines show position of 13a.

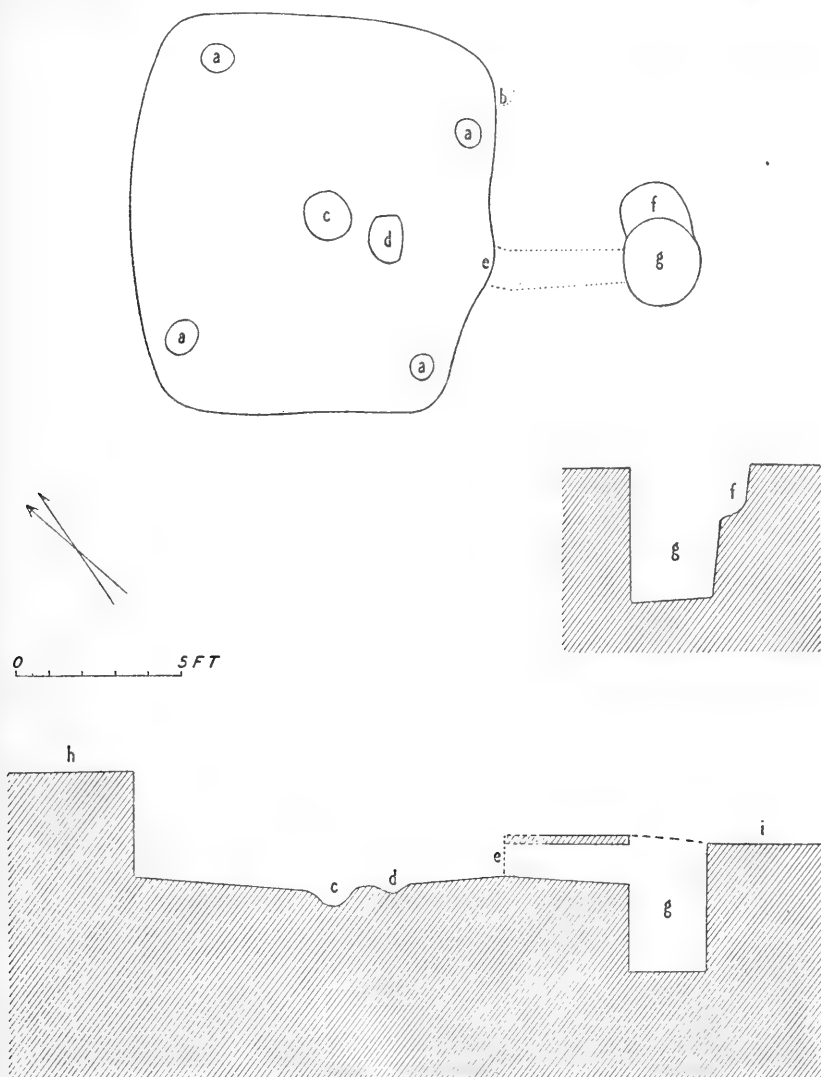
FIGURE 32.—Structure 14. *a*, holes for main support posts; *b*, wall pocket; *c*, fire pit; *d*, ladder box; *e*, ventilator opening; *f* and *g*, exterior opening to ventilator shaft; *h*, platform of dance court dais; *i*, floor of dance court.

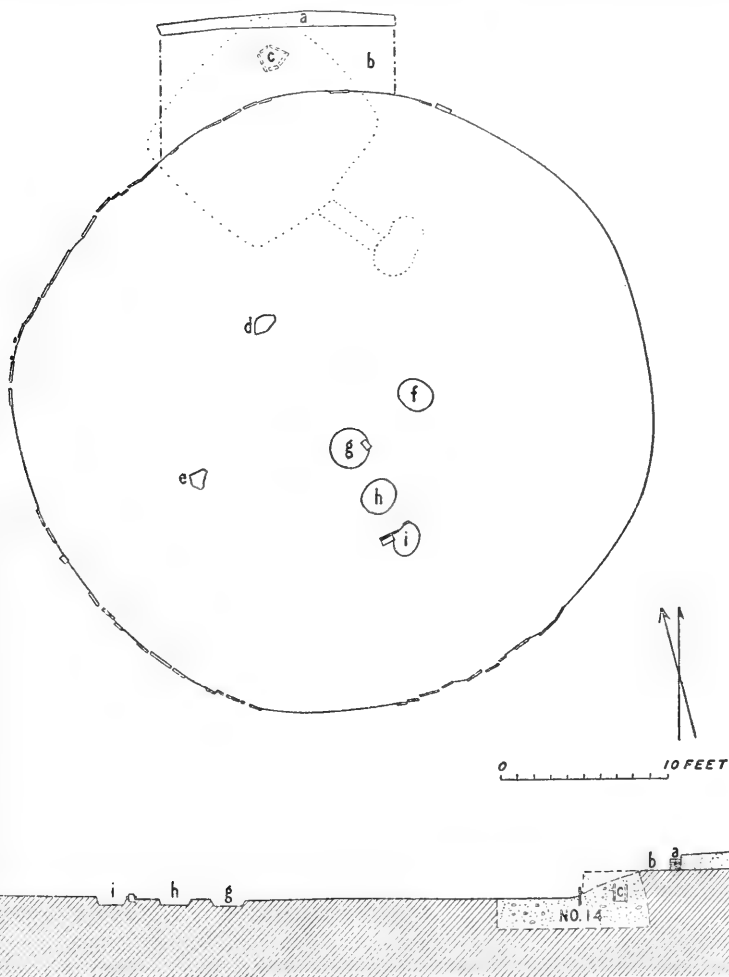
FIGURE 33.—Dance court. *a*, masonry wall; *b*, dais; *c*, fire pit; *d* and *c*, stones embedded in floor; *f*, basin in floor; *g*, fire pit; *h*, ash pit; *i*, basin in floor. Dotted lines show location of structure 14.

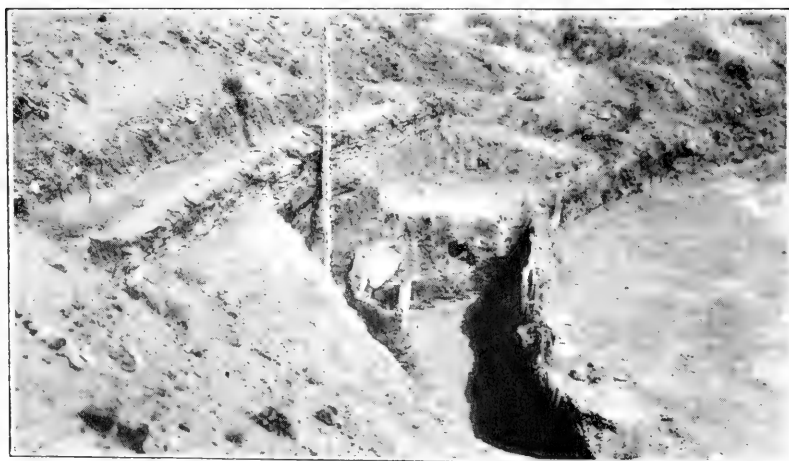
b. Portion of structure 14 underlying dance court and dais.

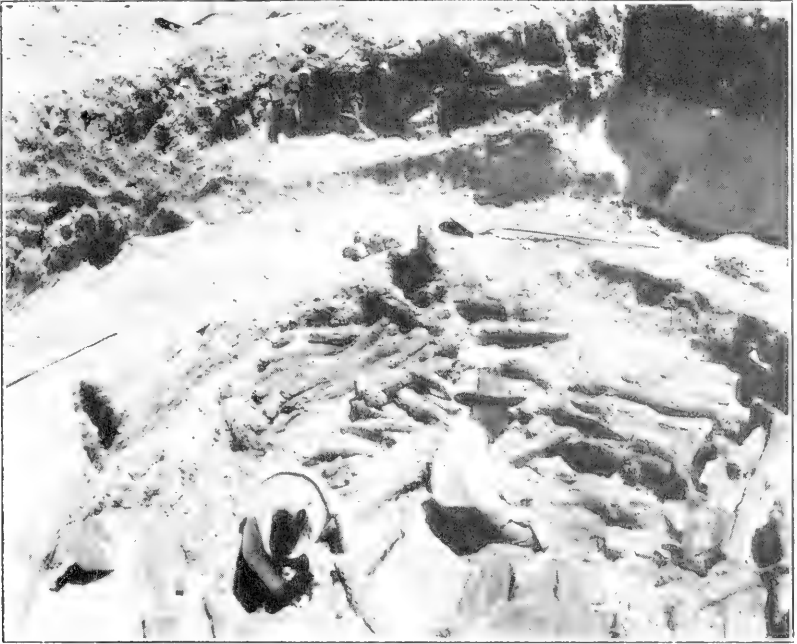
a. Burned roof timbers in pt. of structure 15.

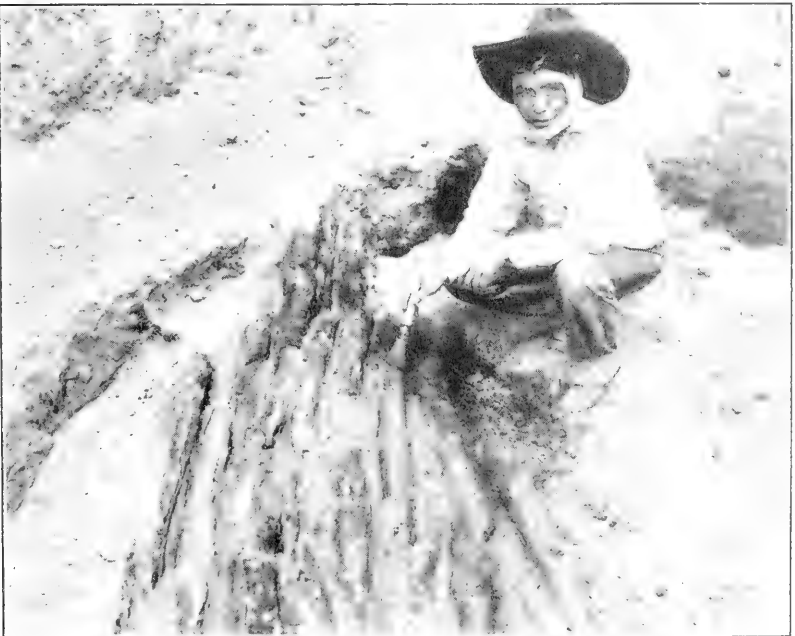
b. Series of slanting side poles for roof of structure 15.

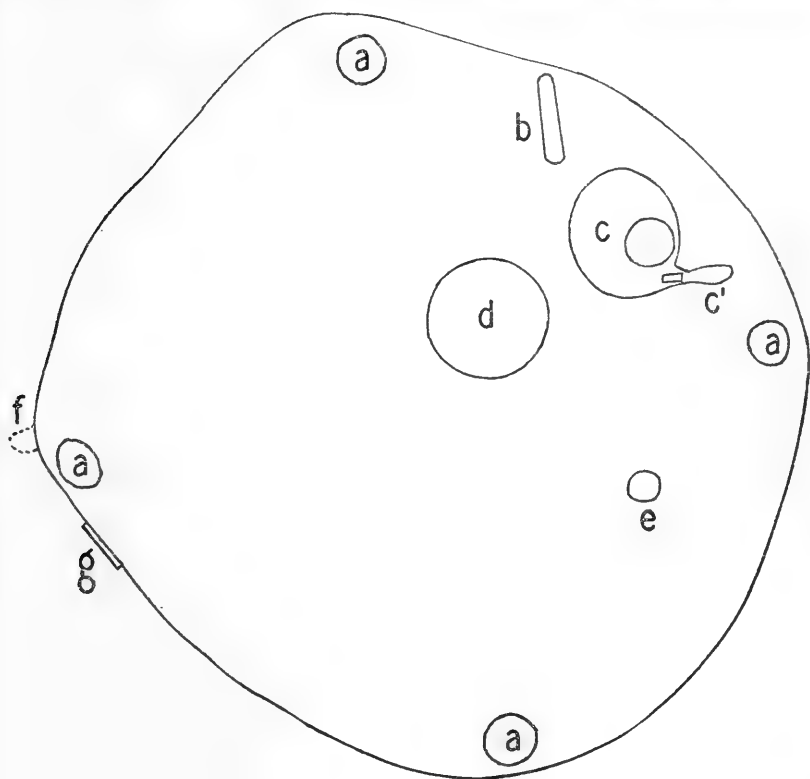
0 5 FEET.

FIGURE 34.—Brush shelter. *a*, holes for support posts; *b*, stone in floor; *c*, storage pit in floor; *d*, fire pit; *e*, storage hole in floor; *f*, placement for roof brace; *g*, slab in wall.

The storage hole (fig. 34, *e*) was 5½ inches (13.97 cm) in diameter and had a depth of 5 inches (12.7 cm).

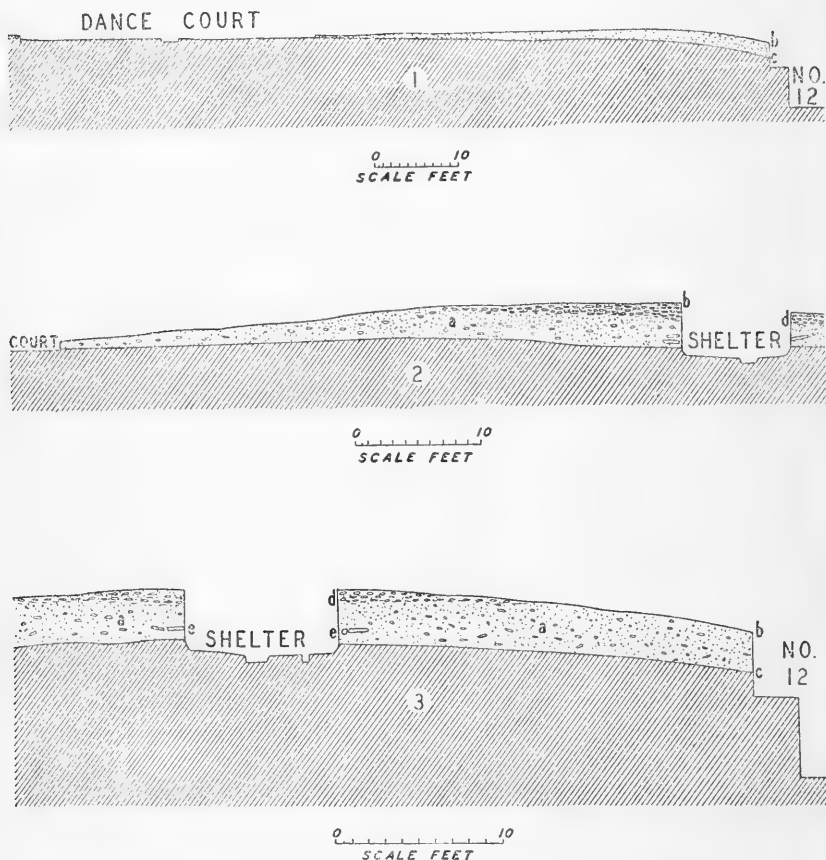
FIGURE 35.—Sections for structure 12, dance court and shelter.

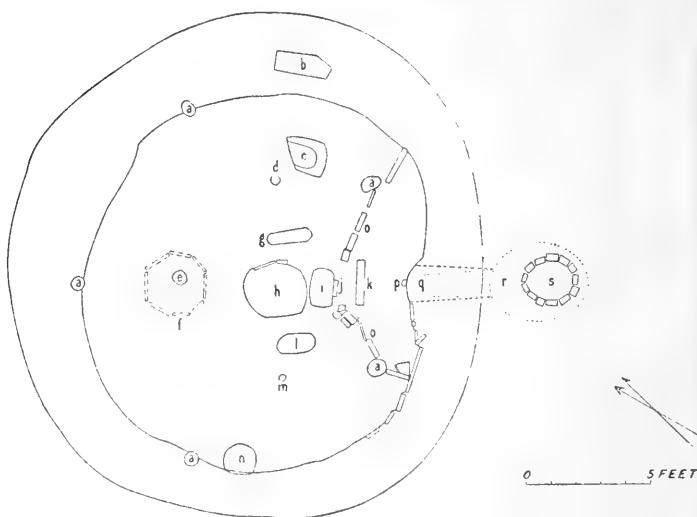
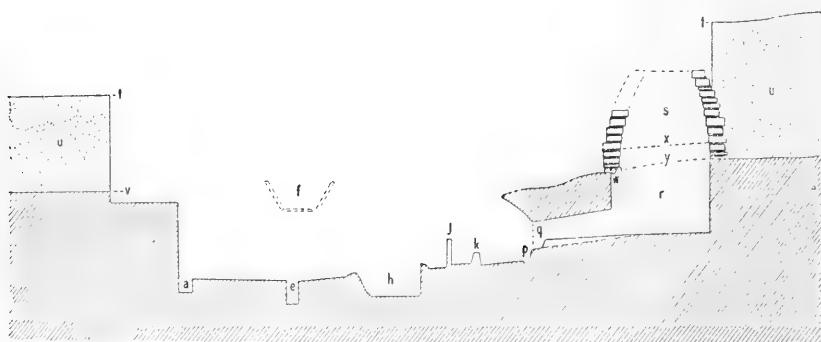
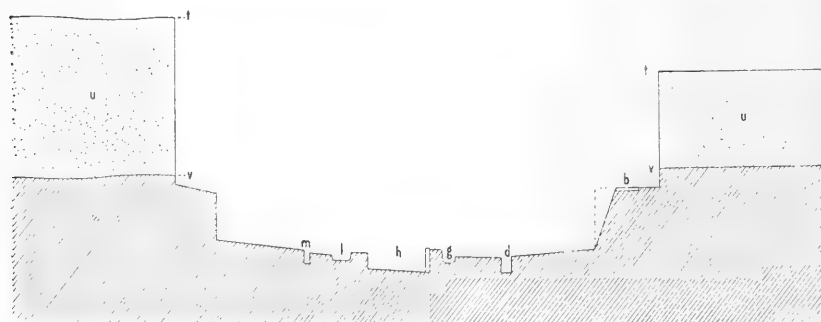
FIGURE 36.—Structure 15. *a*, holes for support posts; *b*, stone embedded in bench top; *c*, metate on floor; *d*, small storage hole; *e*, sipapu; *f*, fire pit; *g*, basin in floor; *h*, fire pit; *i*, ash pit; *j*, deflector; *k*, step and ladder brace; *l*, basin in floor; *m*, storage hole in floor; *n*, storage basin; *o*, compartment wall; *p*, hole for post to brace cover stone; *q*, ventilator opening; *r*, base of ventilator shaft; *s*, ventilator opening on ground; *t*, present surface; *u*, sand accumulation; *v*, original surface; *w*, wooden support for masonry; *x*, floor in granary; *y*, surface of accumulated material in shaft.
